Reconstruction Finance Corporation
Mining Division
Report of Supervising Engineer

Docket No. _____ B-NP 4671
Date Authorization for Exam. Recd. _____ Dec 15, 1942
Date of Examination, inclusive _____ Dec 16, 1942
Date of Report _____ Dec. 1942

A. F. Bohse and M. E. FULK
245 East A Ave, Glendale, Arizona

2. Character of Project

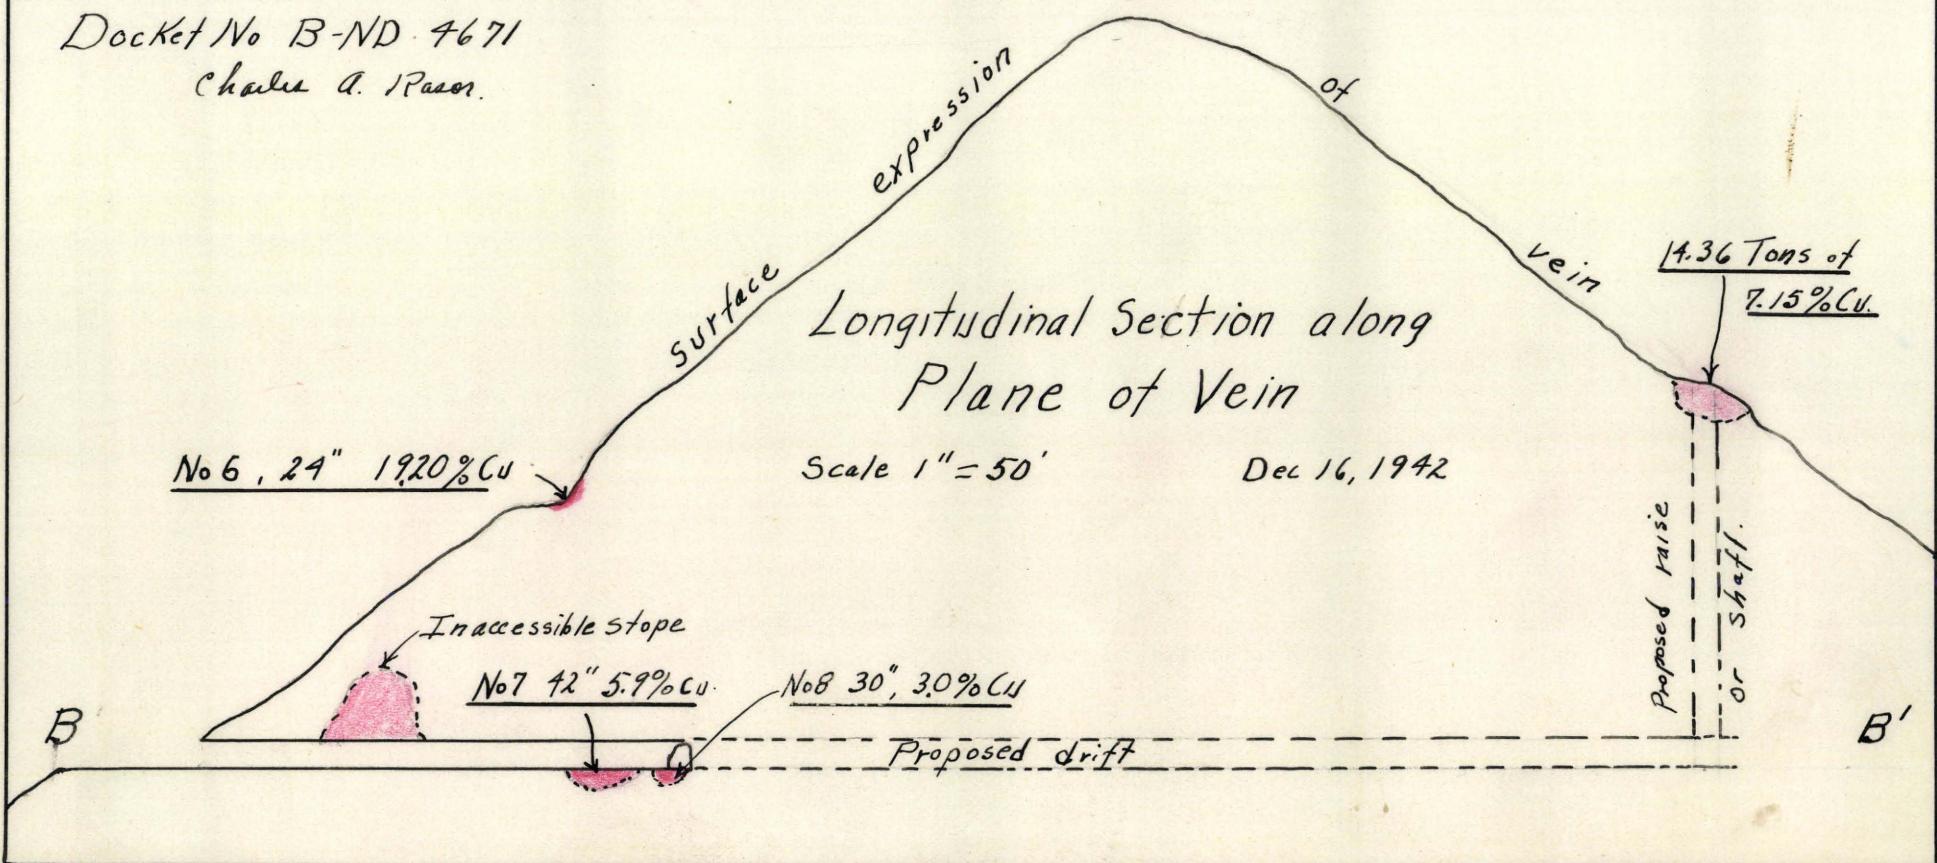
Longitudinal Section along Plane of Vein

No 6, 24" 19.20% Cu

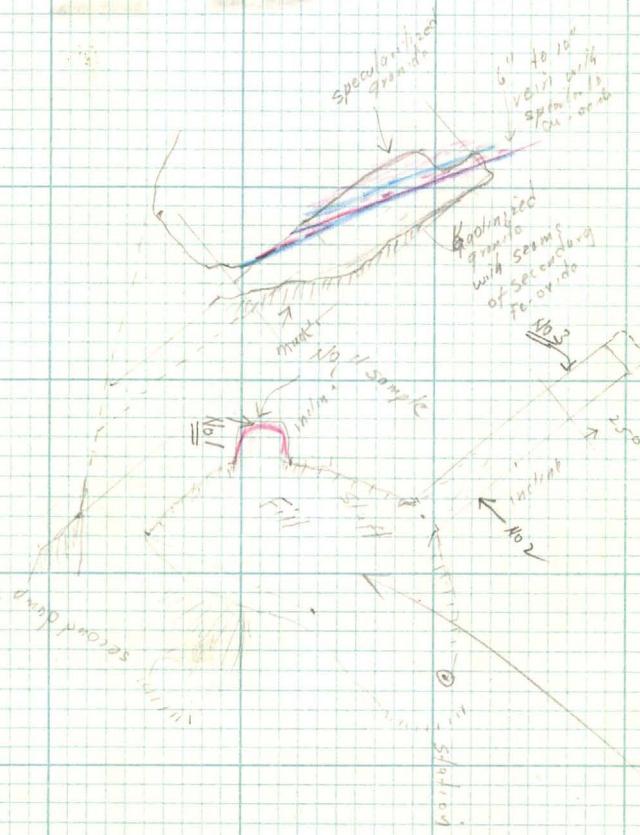
No 1

48" face

greenish stain
14 ft. 0 inches

No 2

36" cut near

Portah
cu-oxide in
Fe oxide

No 3

18" cut in vein

near rear.

where 1/4 tons were mine'd
11/11/1937
